PARKS COLL OF SAINT LOUIS UNIV CAHOKIA ILL
SHOCK PULSE METER ANALYSIS.(U)

SHOCK PULSE METER ANALYSIS

15 OCTOBER 1974

FINAL REPORT

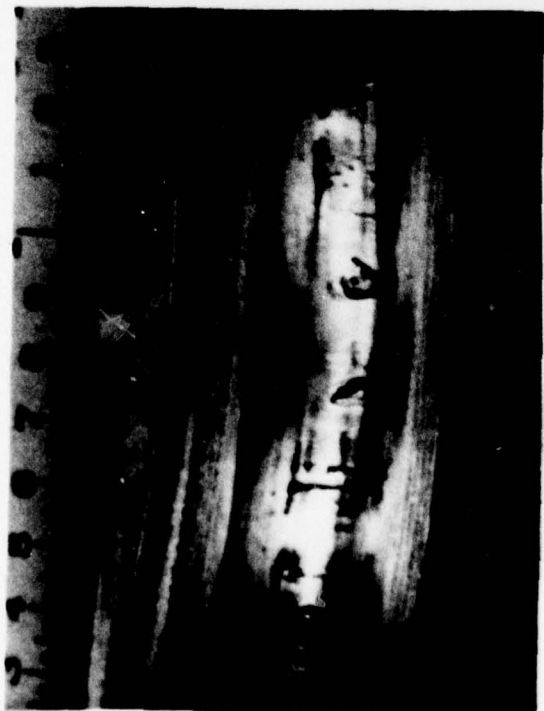
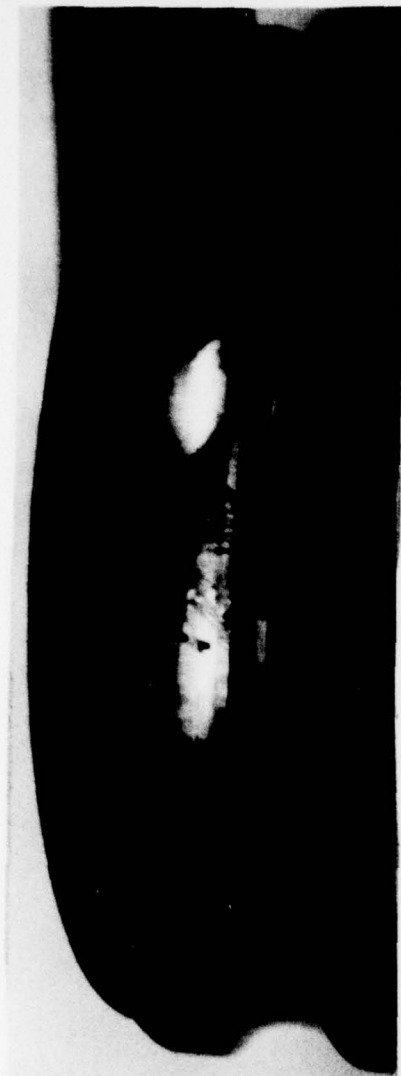
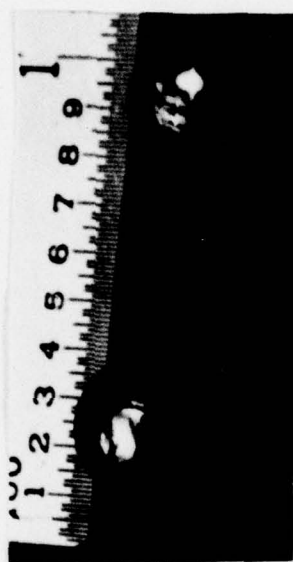
Hanger Bearing
 S/N A20-36705
 A/C 63-8784

REMARKS: Inner Race: Mild Corrosion
Outer Race: Pitting and Corrosion
Rolling Elements: Corrosion, Mild Pitting

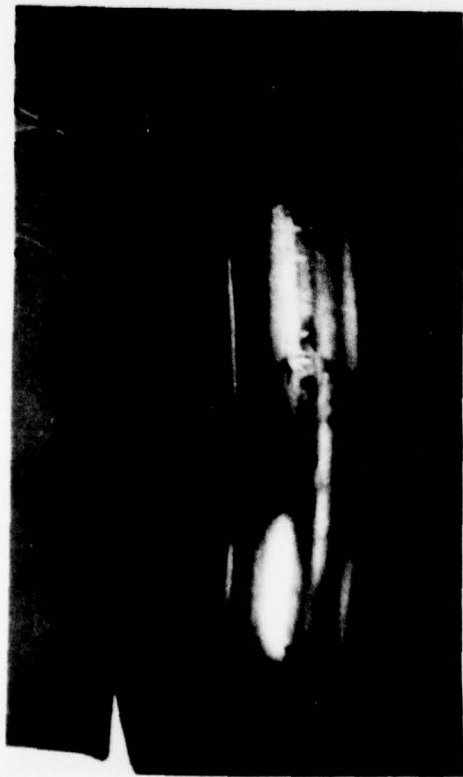
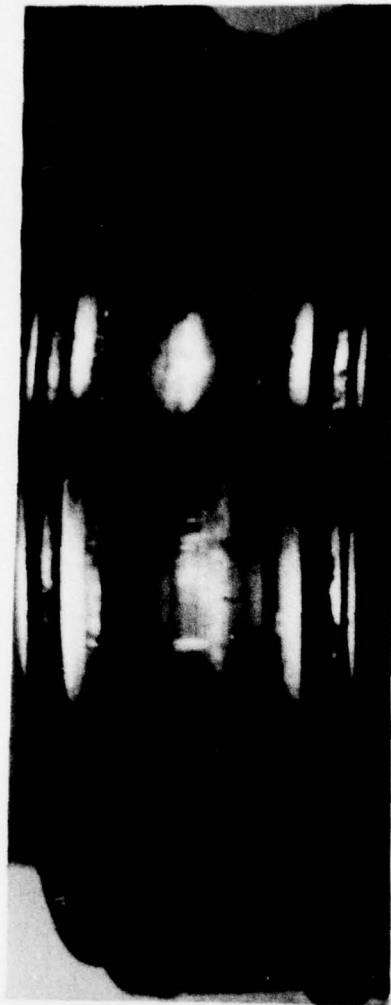
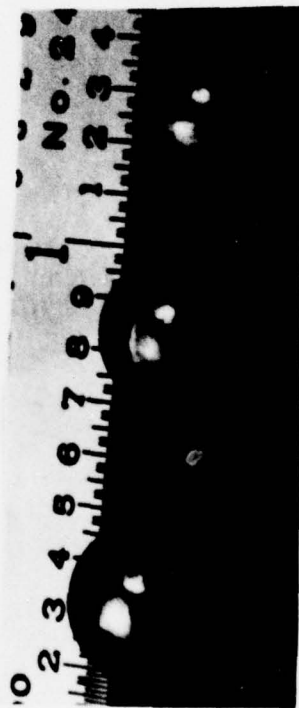
Hanger Bearing
P/N A20-44891
A/C 65-9519

Each of the four hanger bearings removed exceeded the normal range signifying a bearing without defect. Refer to reference 2 for the coded normalizing graph. Since hanger bearing A20-44891 had a level which fell in the caution area, it was removed to correlate its tear down evidence with its plot on the normalizing graph.

REMARKS: Outer Race: Metal Fatigue, Pitting, Flaking Corrosion
Inner Race: Corrosion, Pitting
Rolling Elements: Corrosion, Pitting

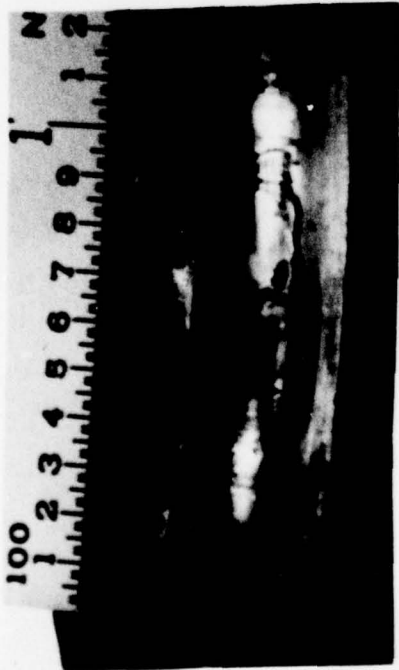
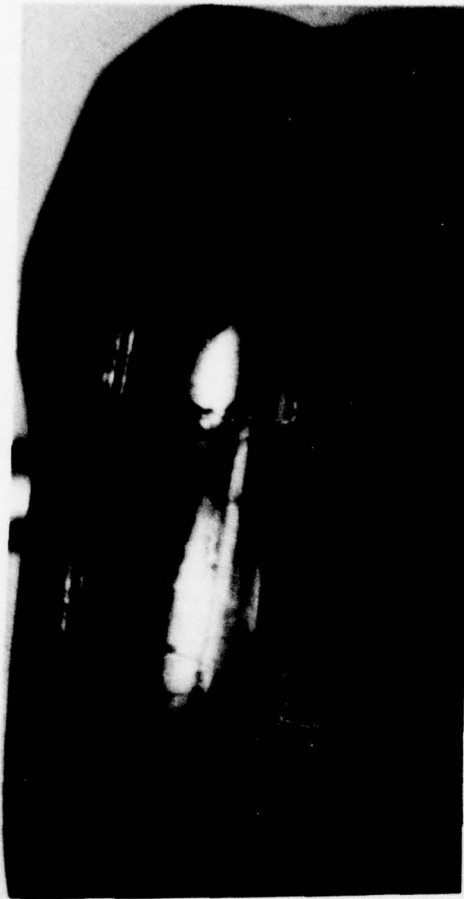
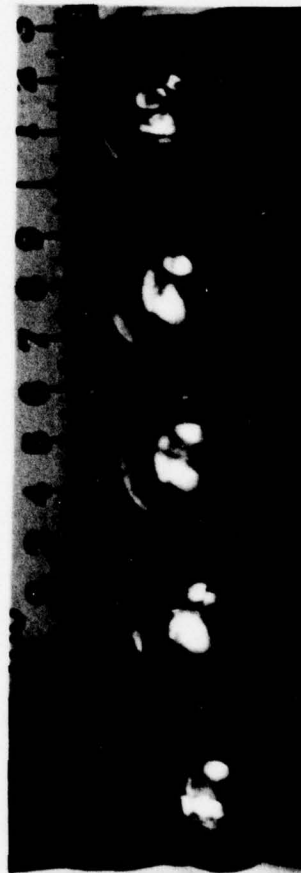
Hanger Bearing
P/N A20-55389
A/C 69-15949

REMARKS: Inner Race: Light Corrosion
Balls: Light Corrosion, Evidence of Skidding, Some Pitting
Outer Race: Corrosion, Pitting, Evidence of Skidding

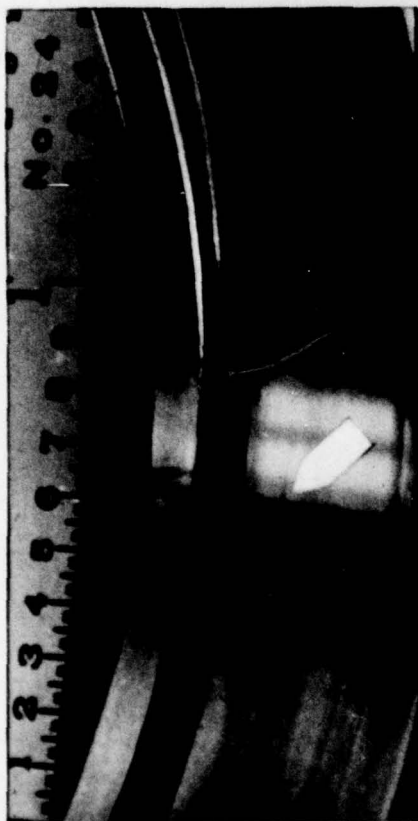
Roller Bearing
S/N 21020
Outer Race

The output drive quill roller bearing showed one scratch about 1/8" long in the outer race. All other damage was due to minor corrosion and pitting. The Duplex Bearing Set showed damage to the cages of both bearings due to inner race contact, some small scratches and minor corrosion.

Outer Race: Light Pitting and Corrosion
1 scratch

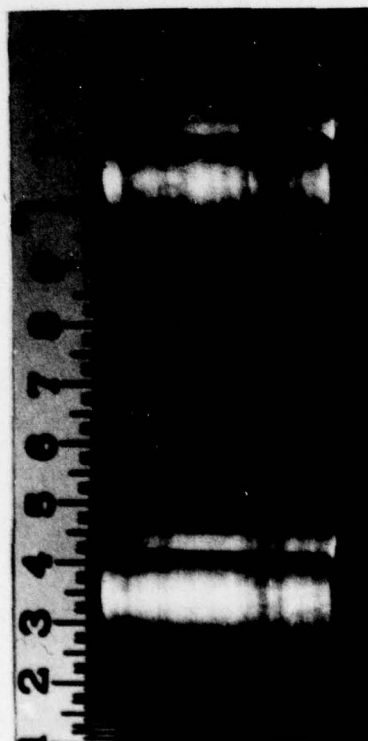
Roller Bearing
S/N 21020
Rollers

Rollers: Pitting & Corrosion

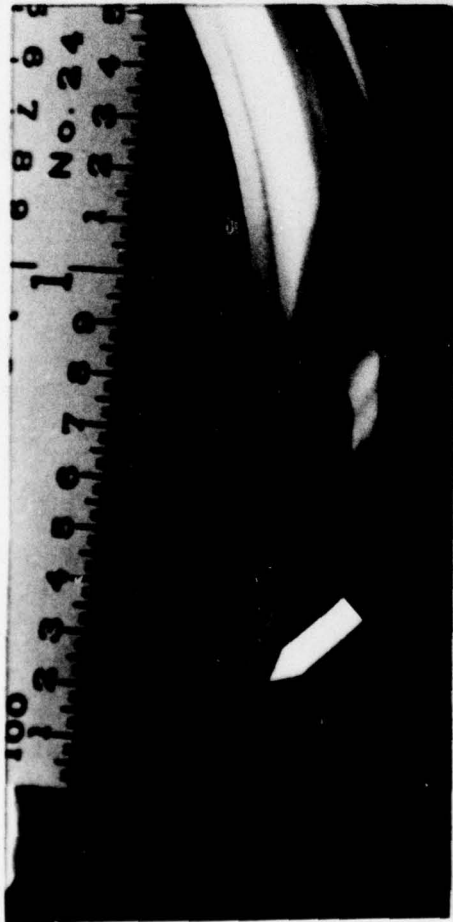
Duplex Ball Bearing
S/N 8199-H-2
Outer Race

Outer Race: Corrosion on Thrust Side

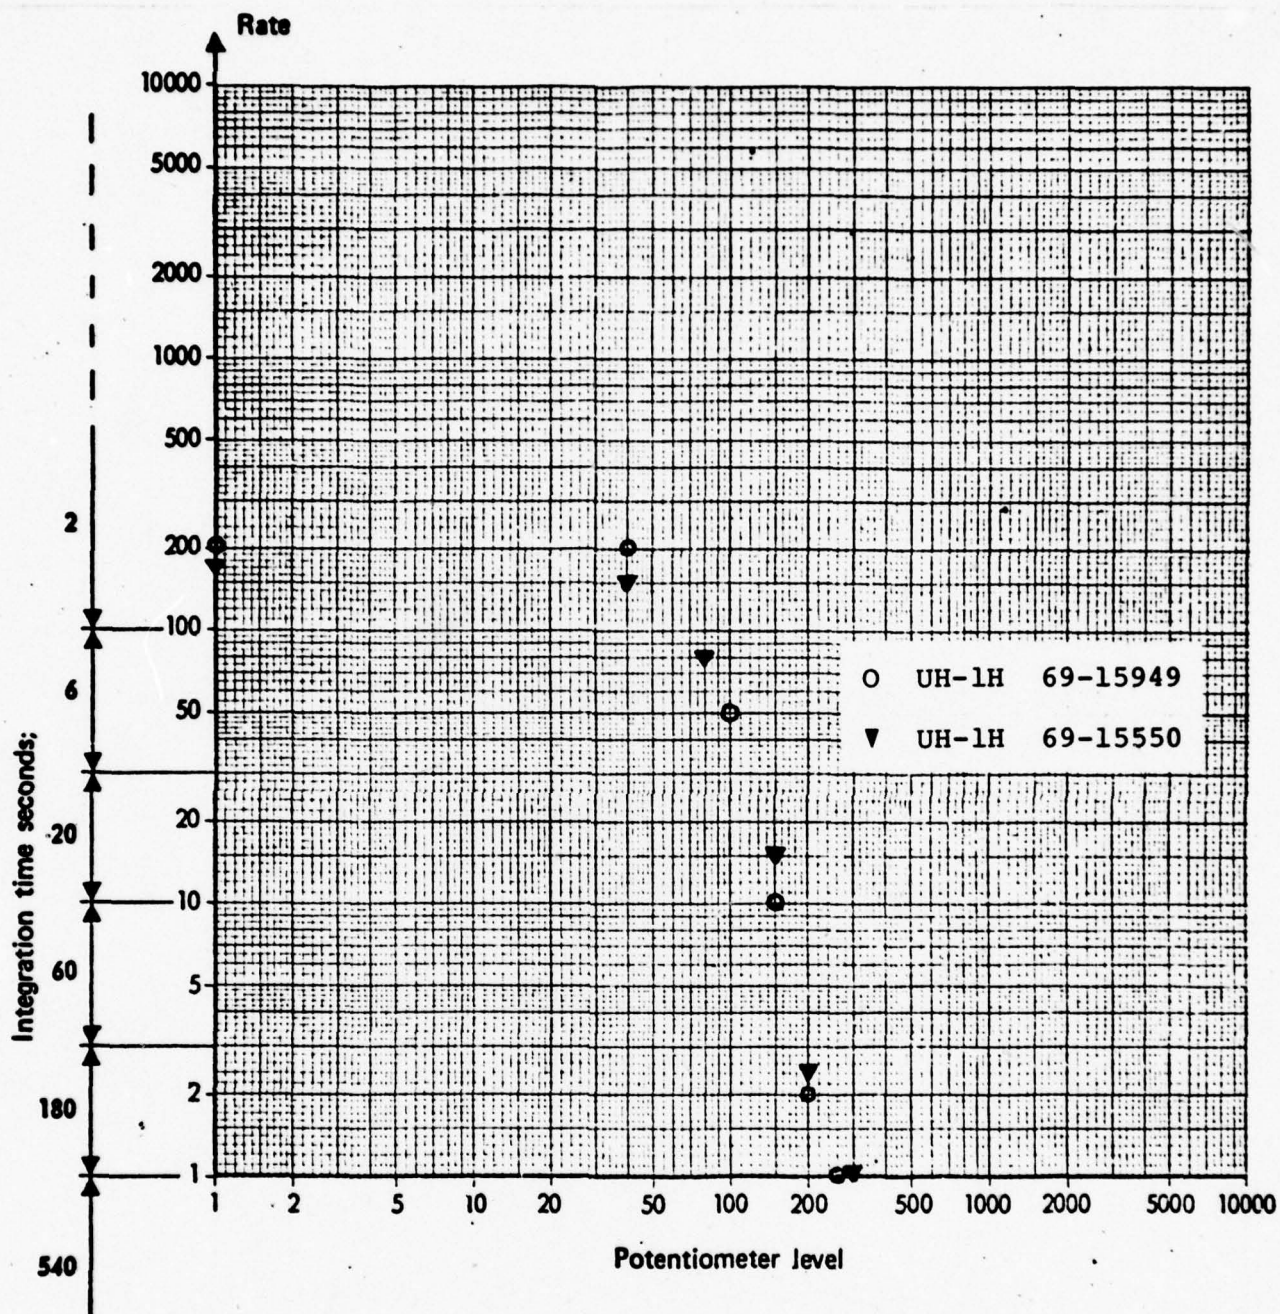
Although not a contractual requirement, data was collected with the shock pulse meter under conditions other than ground runs. Figure 24 shows a comparison of ground, hover-in-ground effect, low and high speed flight, and autorotation conditions. The data was collected with an accelerometer mounted on the input drive quill on UH-1H 69-15550. Figure 25 compares two UH-1H helicopters, both at the same high-speed flight condition. At least as far as the input drive quill is concerned, the various flight conditions had a negligible influence on the shape of the shock emission envelope or on the rate or level readings. The shock emission envelopes fall quite well within the scatter of the bulk of the readings shown in Figure 16. More information will be required before advancing any conclusions as to optimum sensor location or flight profile to record shock pulse signature.

--- Test Conditions
 Airspeed 110 KTS
 Altitude 3000 ft
 $N_2 = 6600$ RPM
 Torque 31 psi

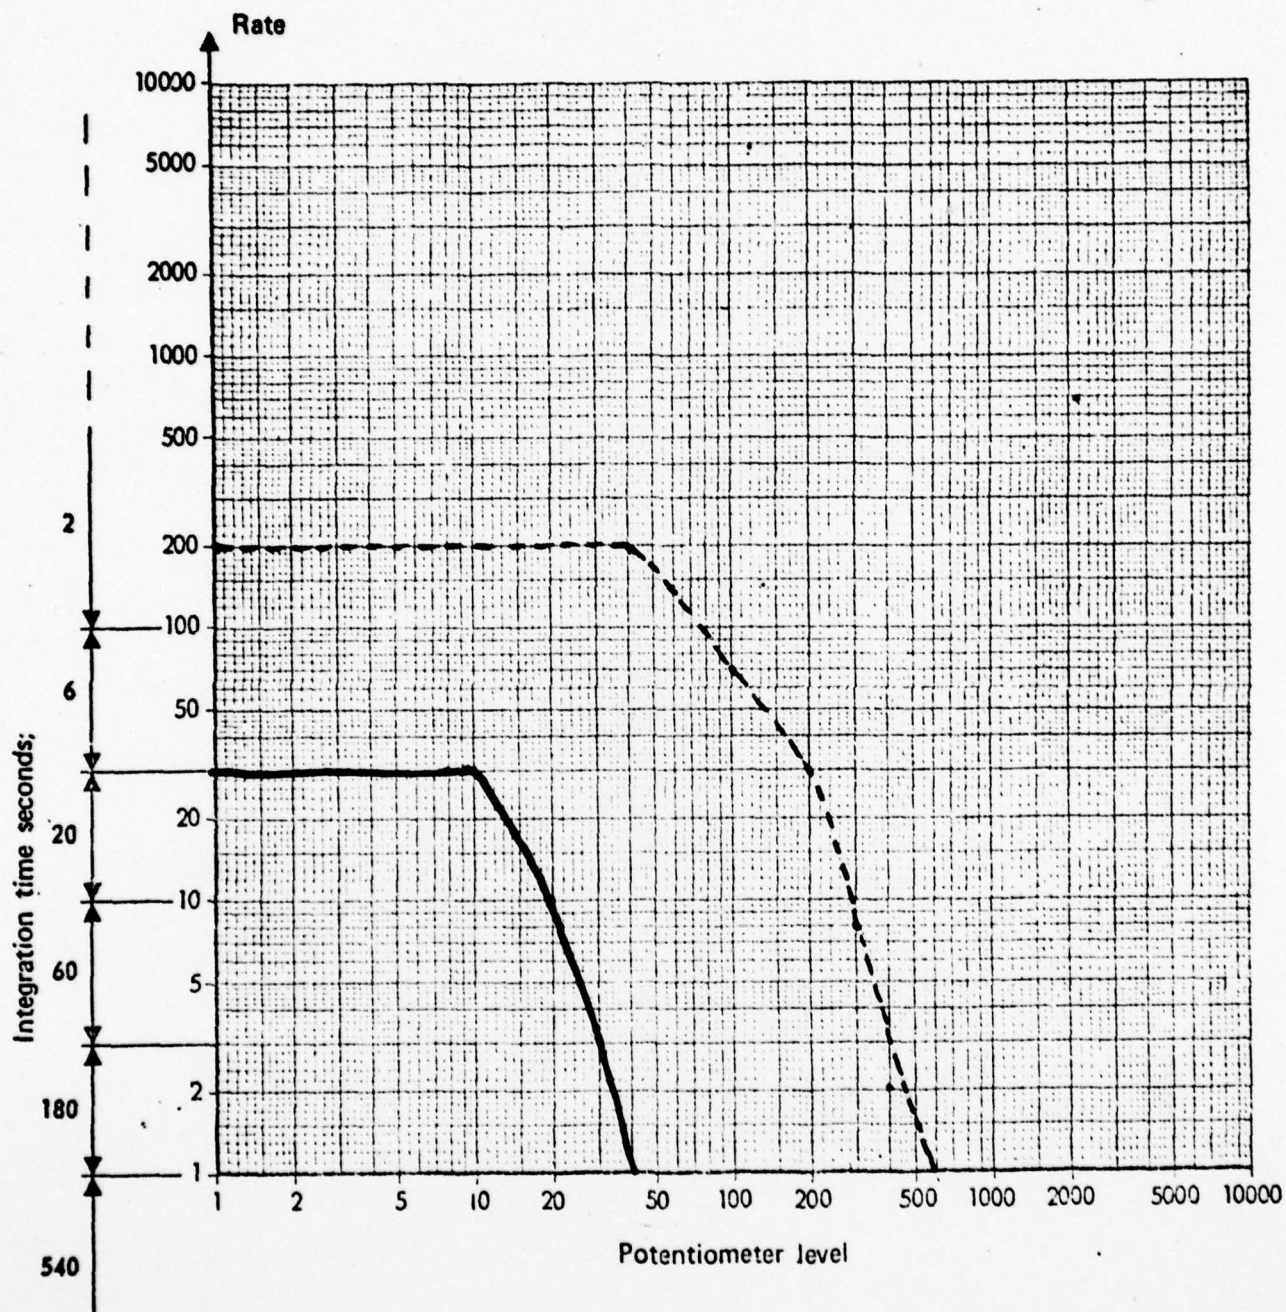
#1 Hanger Bearing

NOTE: Aircraft tested while raining

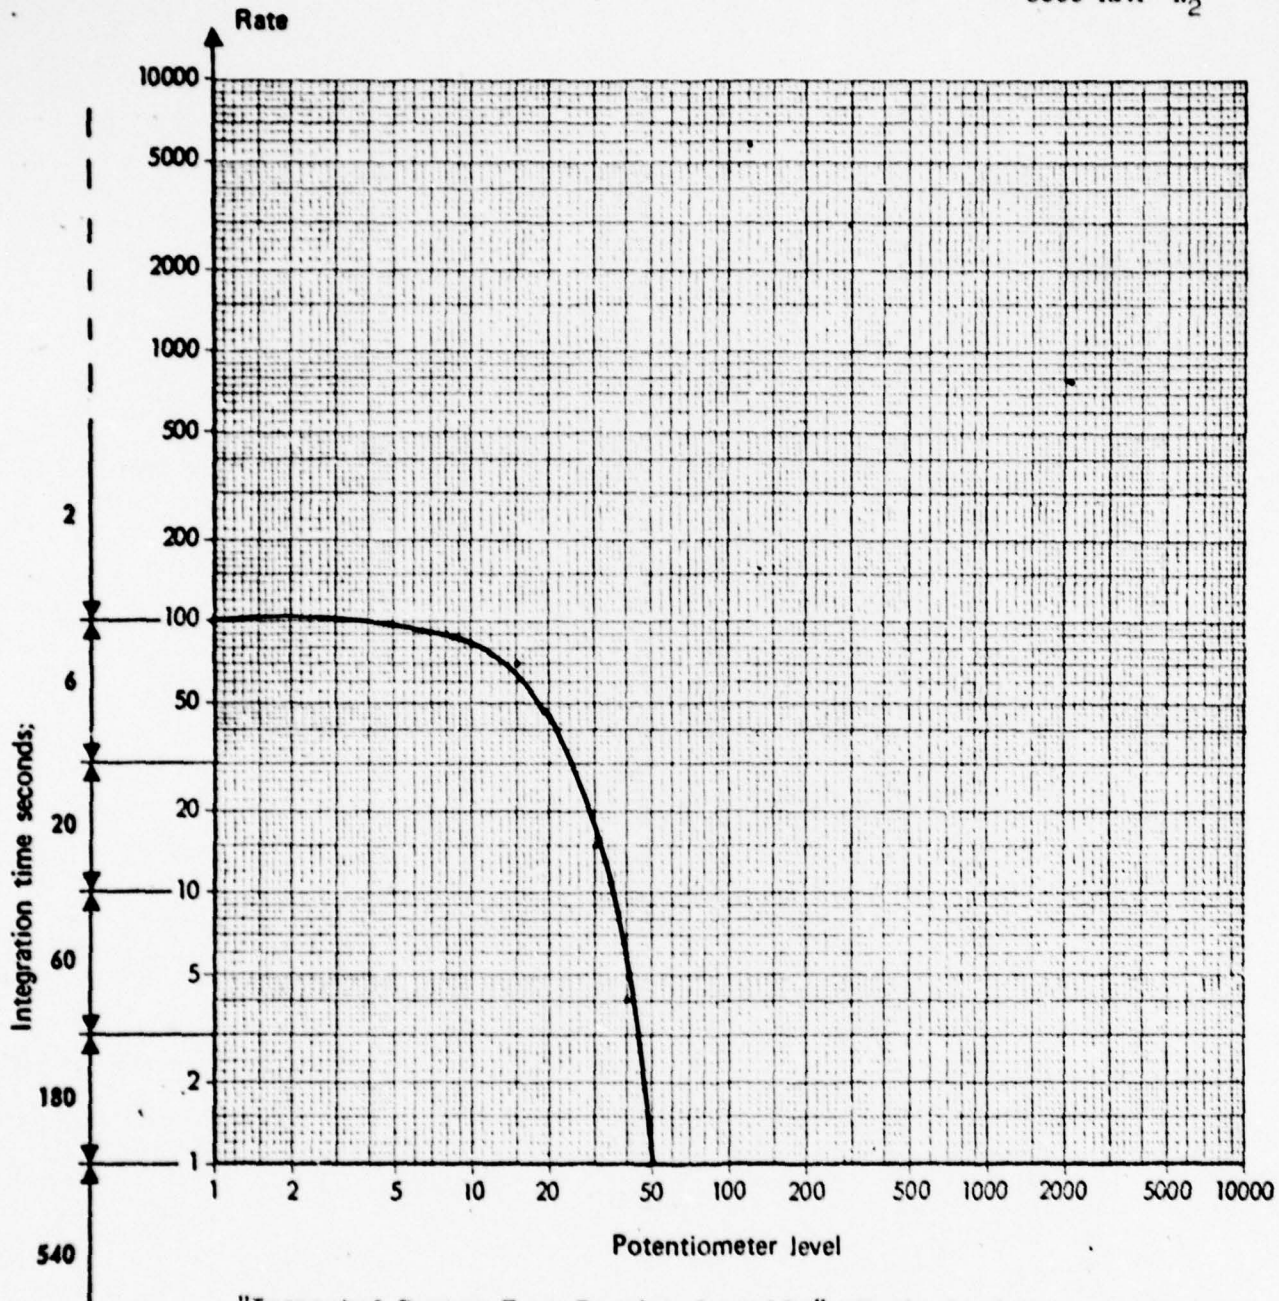
Hanger Bearing

"Inspected Damage Free Bearing Assembly" Typical of new or low
time assemblies tested.

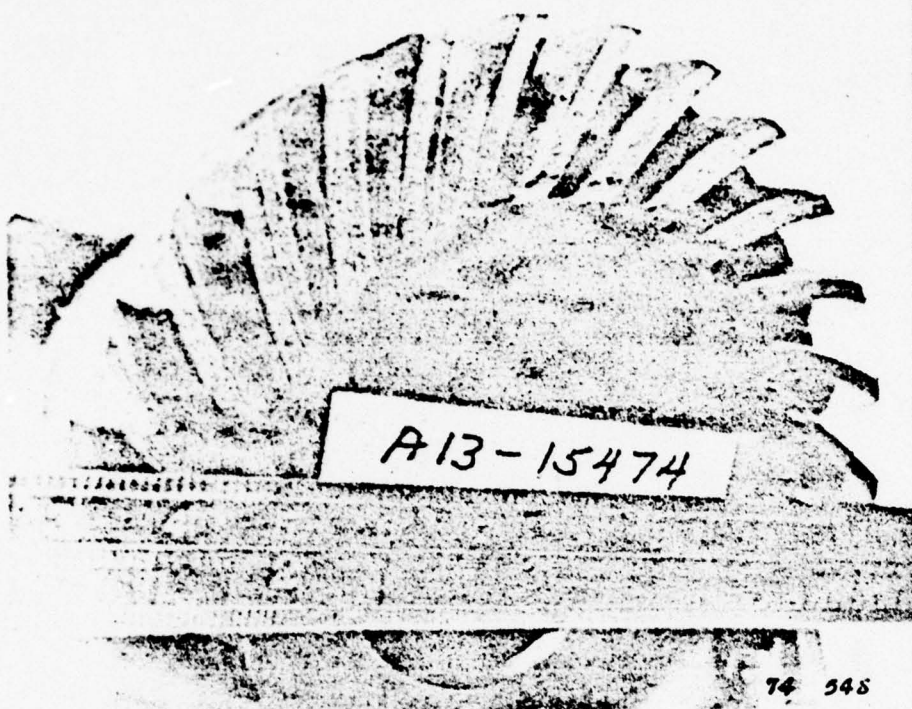
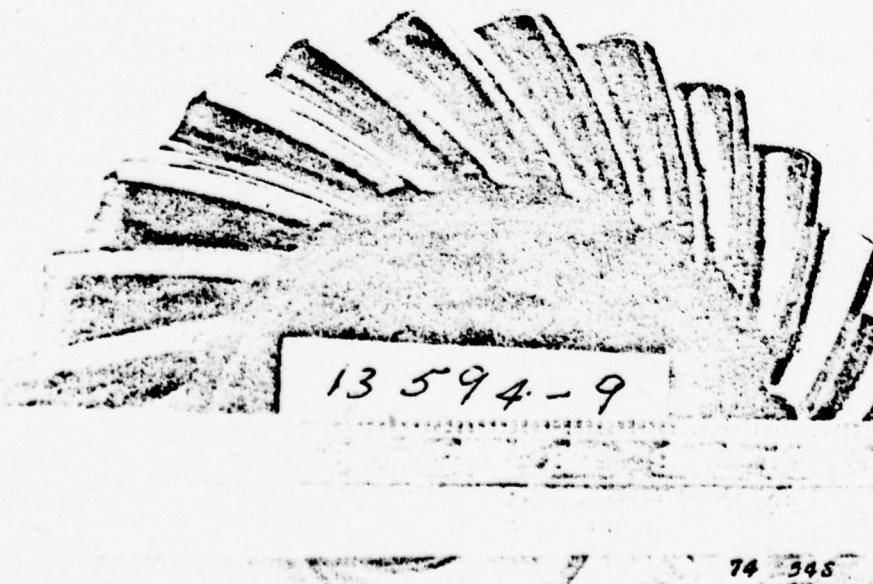
ENCLOSURE 8

OUTPUT GEAR

INPUT GEAR

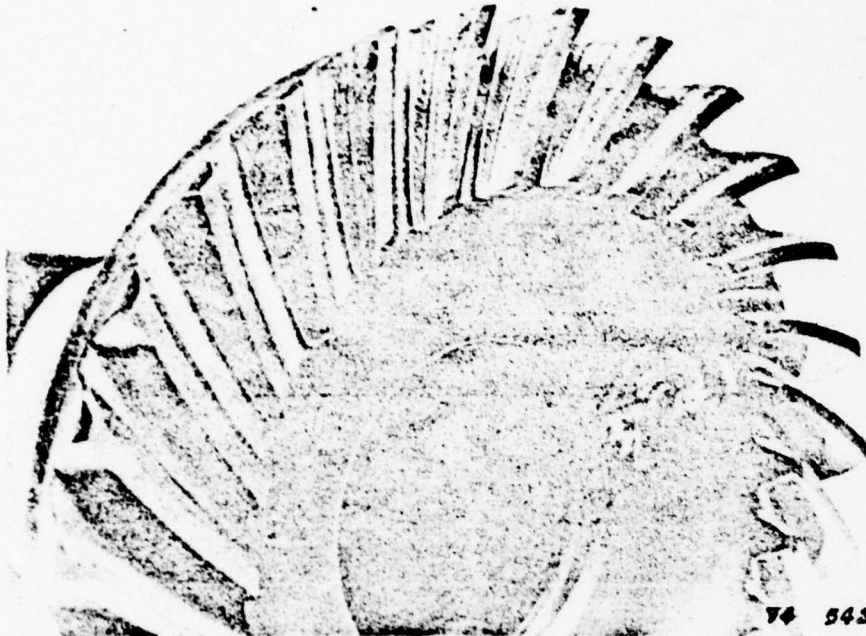
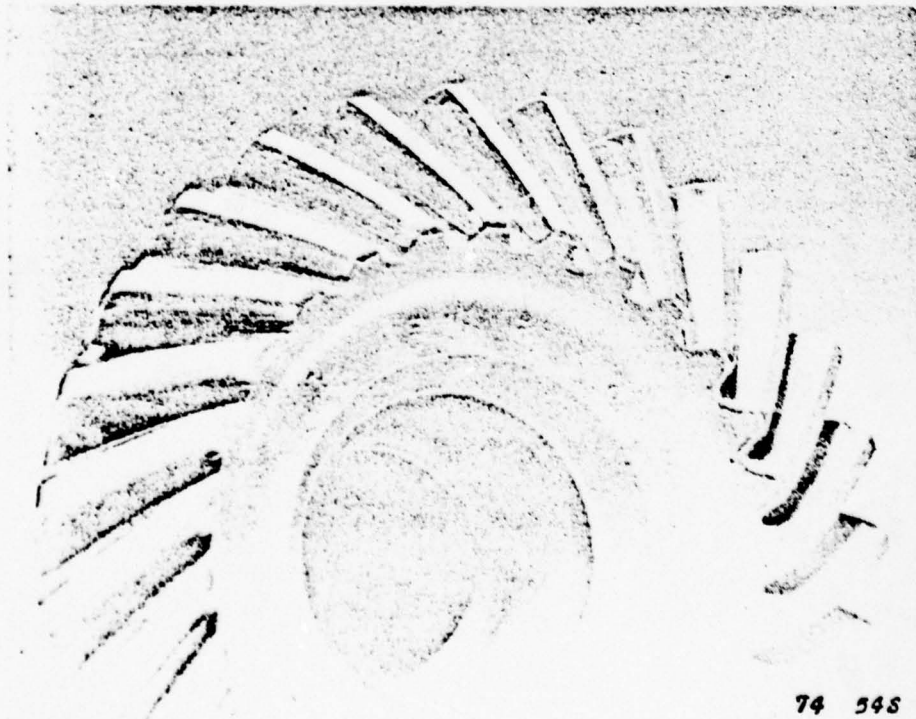
ENCLOSURE 12

At a later stage in the program a third set of gears was installed in this same gear box. These gears were damaged. The damage is shown in Enclosure 12. Data obtained from these gears is shown in Enclosures 13 and 14.

OUTPUT GEAR

INPUT GEAR

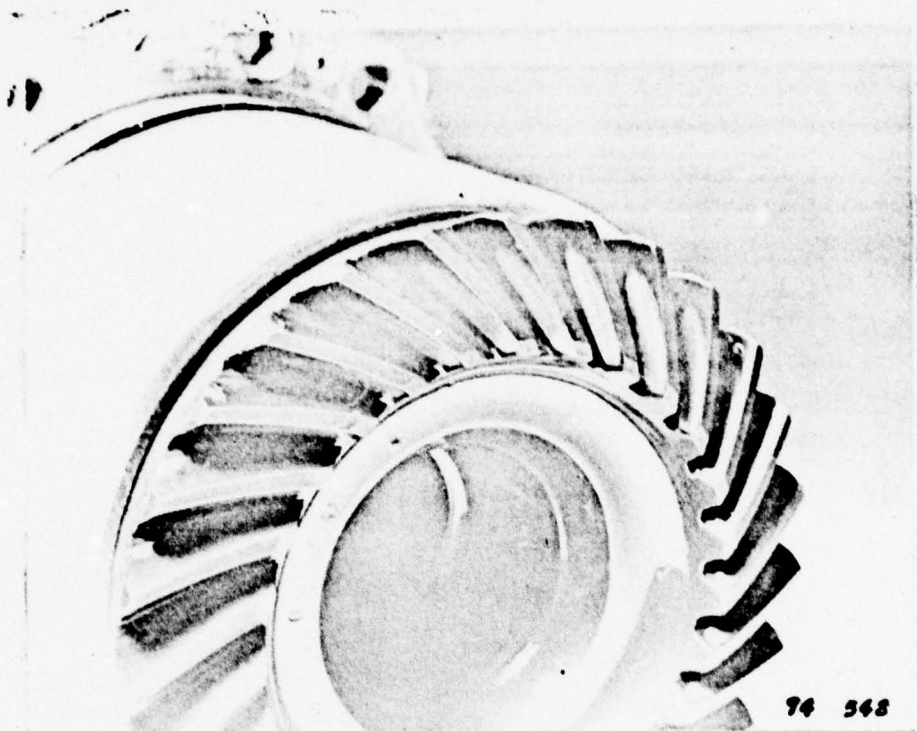
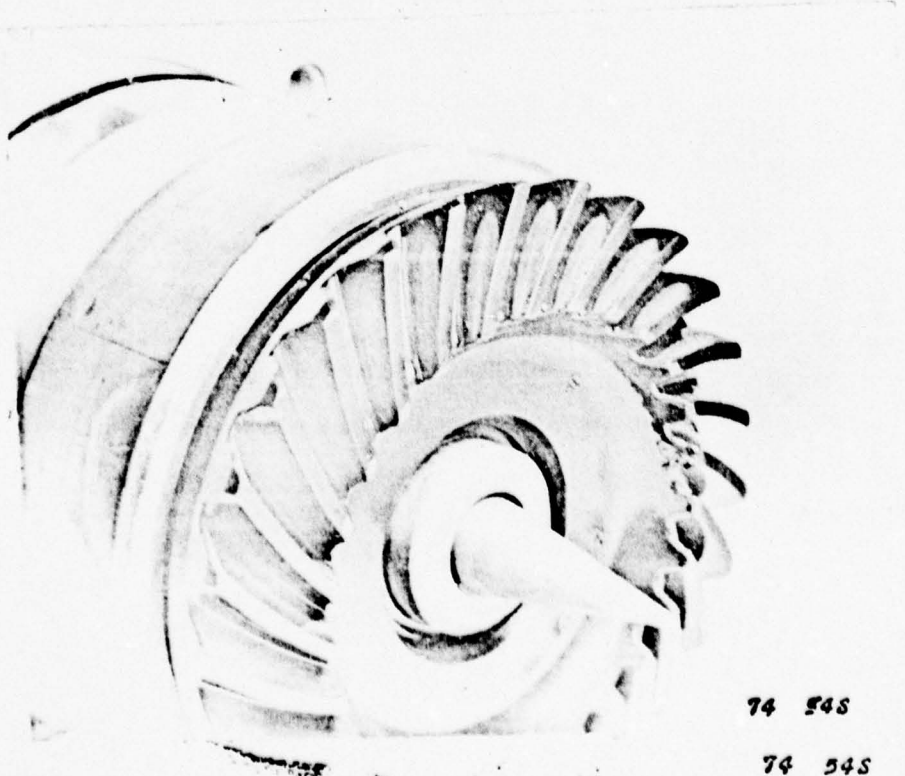
ENCLOSURE 18

This gear box was then removed from the fixture and the gears taken out. They are shown in Enclosure 18. An artificial damage was then put on the output quill gear with a hand grinder, and the two gears reinstalled in the gear box.

INPUT GEAR

OUTPUT GEAR

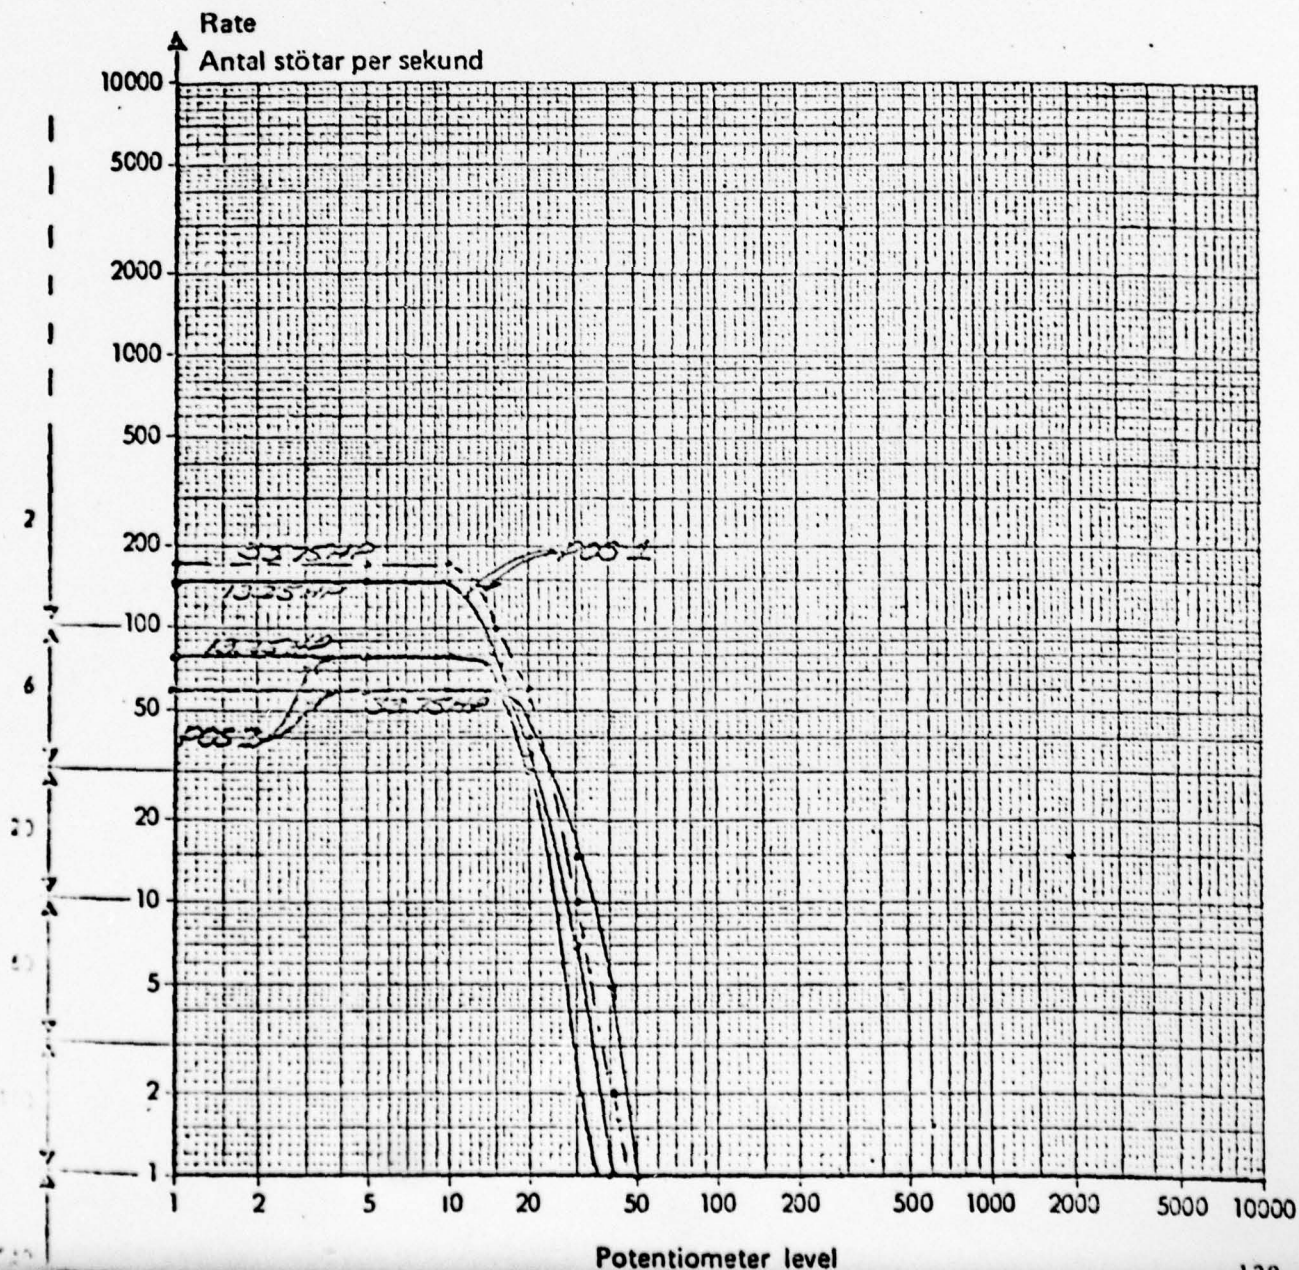
ENCLOSURE 21

Enclosure 21 shows the shock data obtained for the artificially damaged gear implant at a speed of 3540 RPM. Position 1 data has changed back to the more usual curve shape obtained at this speed on the other gear boxes.

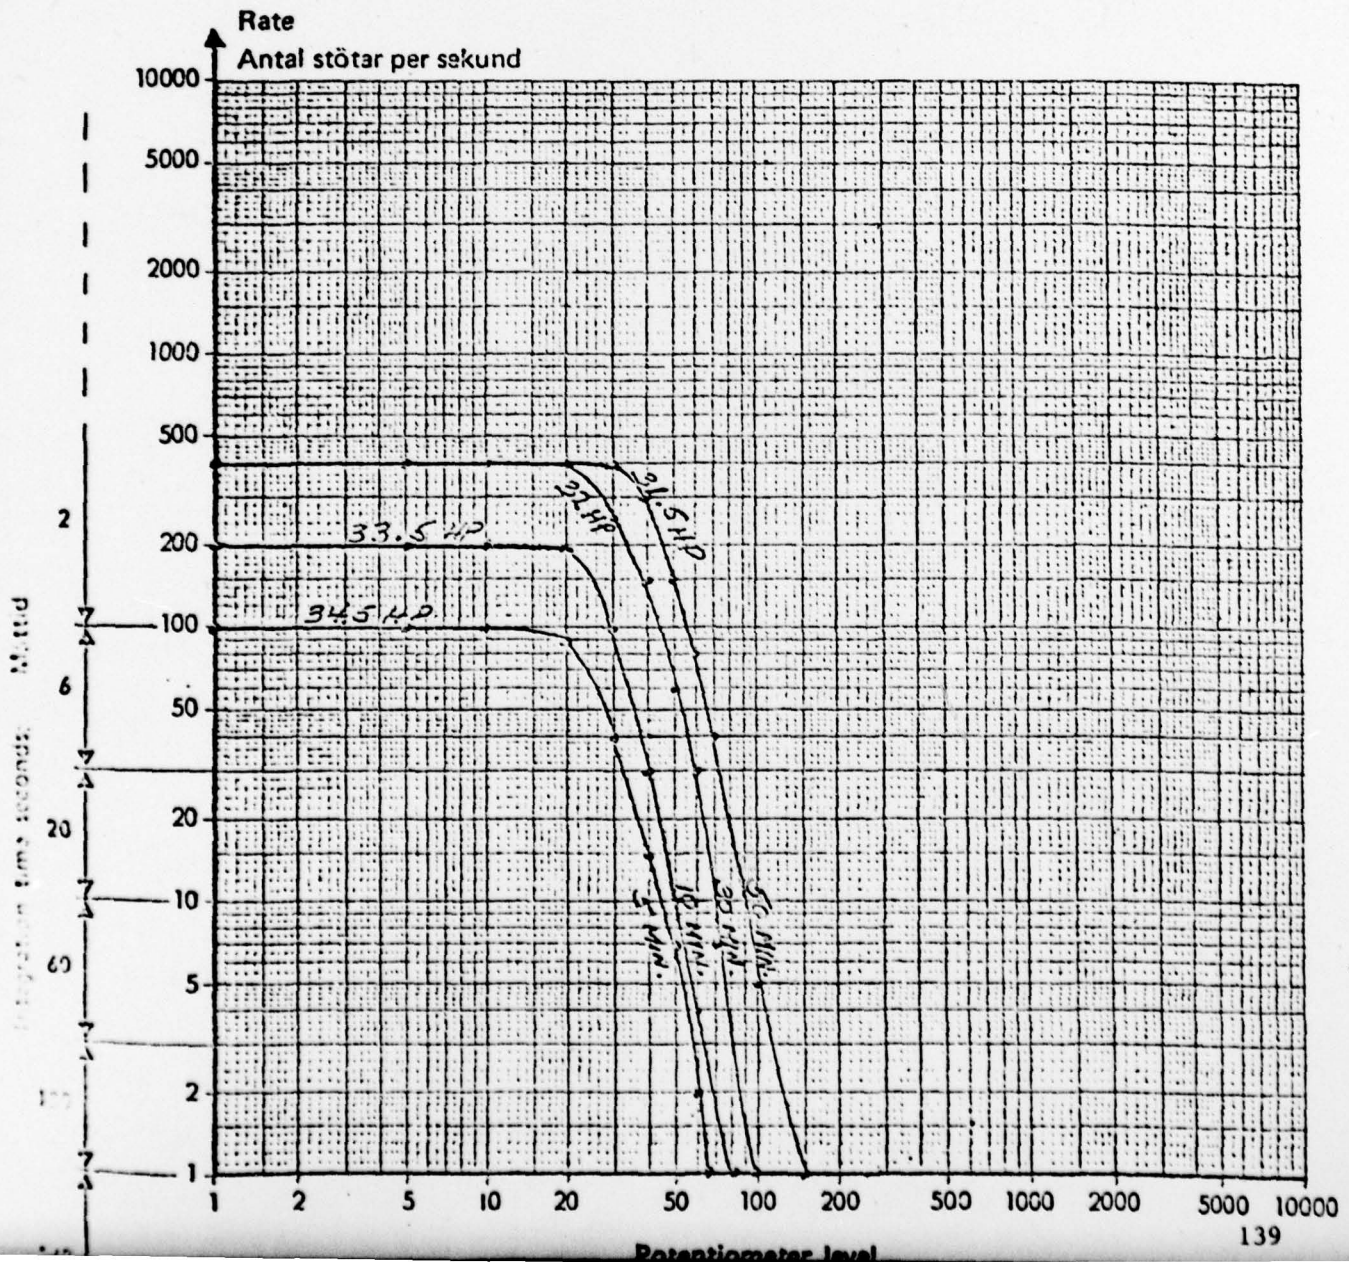
ENCLOSURE 22

At this point the gear box was operated for an extended period of time and data taken periodically to monitor the trend or growth with time. Enclosure 22 shows data acquired after running for 5, 10, 30 and 50 minutes respectively. There was a 4 to 1 growth in shock level which normally indicates damage growth. The unit was again run for an additional hour the next day, however, the curve shape did not change from that shown for 50 minutes in Enclosure 22. Visual examination of the gear box oil showed fine metal particles. The most likely source of these metallic particles is the gear which has been artificially damaged. Because of the roughness at the edges of the artificially damaged area of the gear metal burrs could break off quite easily.

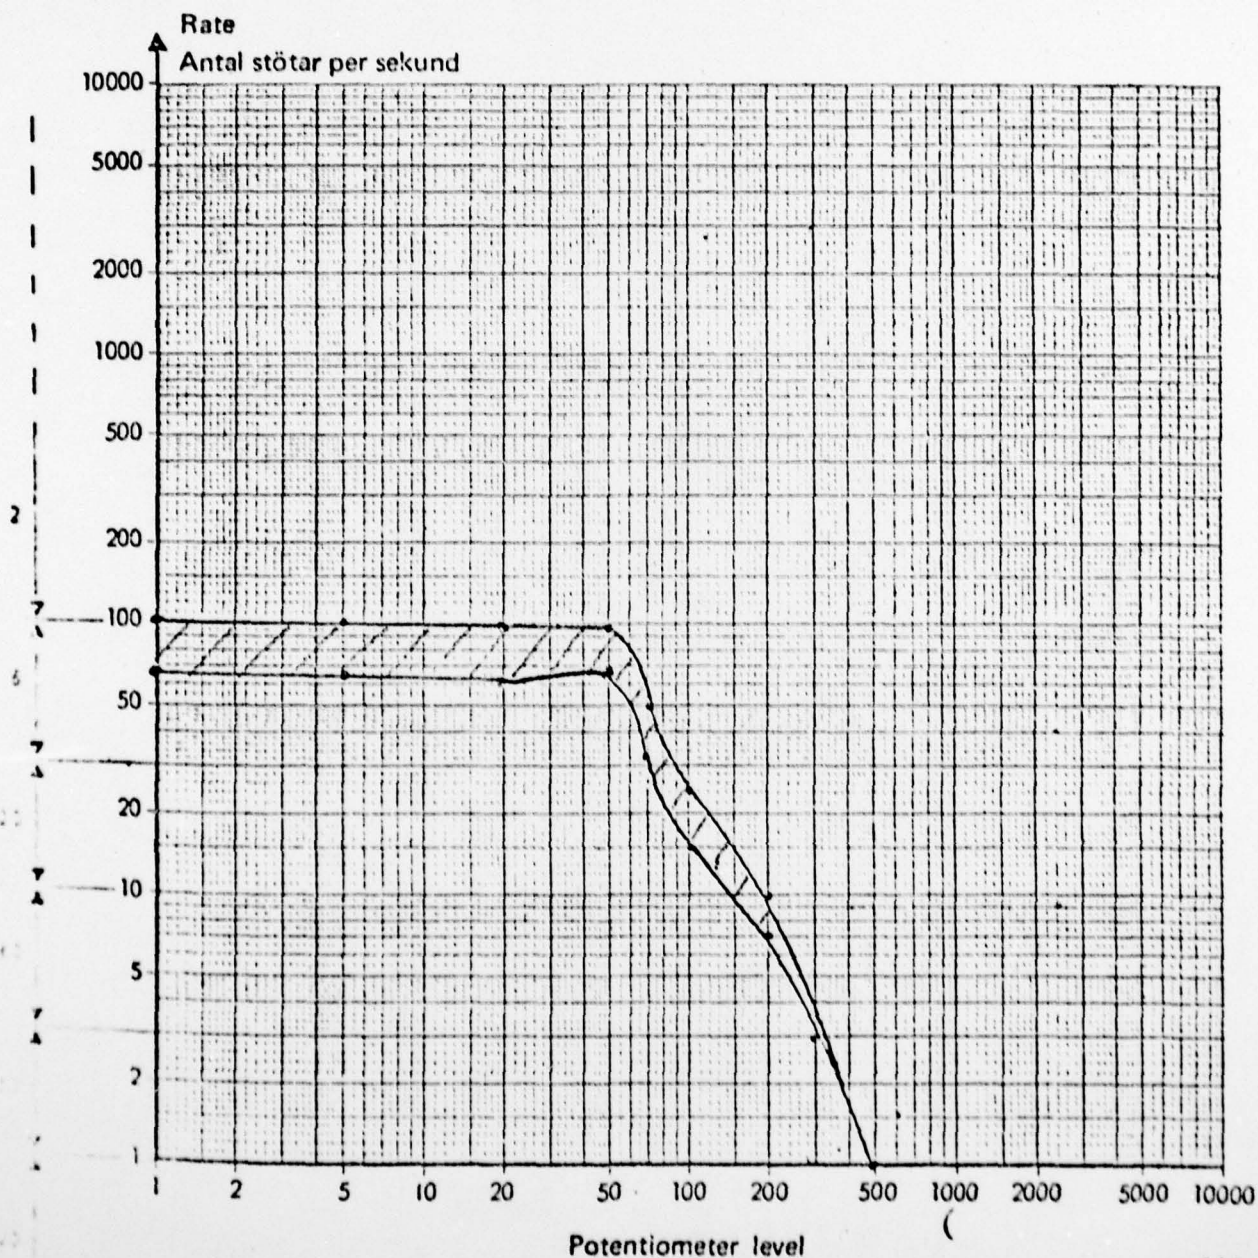
ENCLOSURE 27

Upon request by Parks College an "unknown condition" input quill assembly supplied by Parks College was implanted in the gear box and data again taken. This time the rate readings were also variant. The data is shown in Enclosures 27, 28, and 29. The readings obtained also showed extremely high shock level indicative of bearing damage.

2. The shock pulse technique has again proven successful in isolating a damaged bearing in a gear box as shown in Enclosures 27, 28, 29 and 30. This coupled with the ability to detect incipient gear failure by the effect of the associated particulate contaminant in the lubricant being measured by the MEPA-10A establishes the shock pulse technique as a viable total gear box condition monitoring technique.

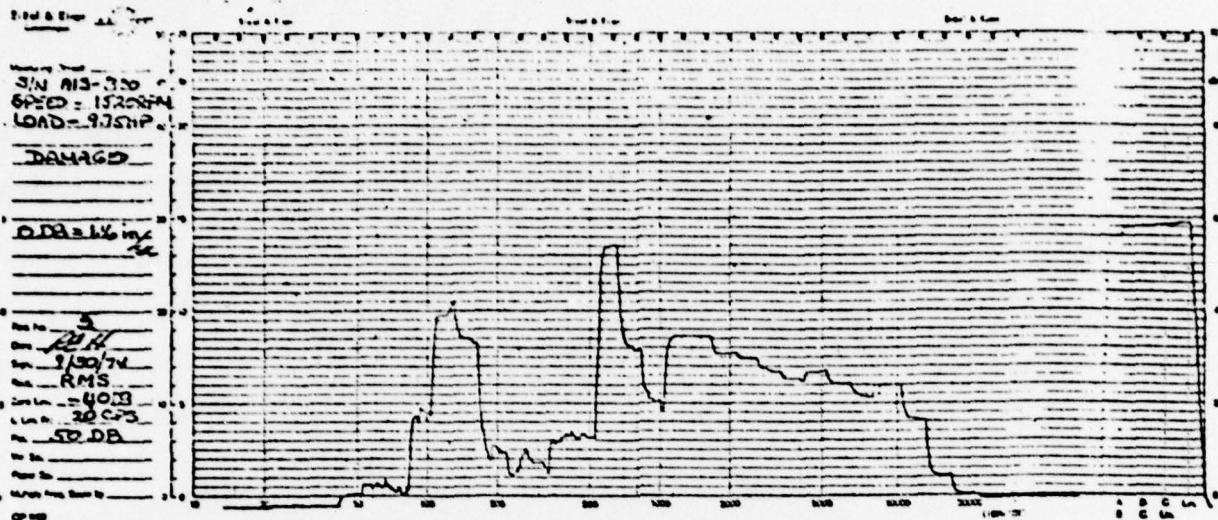
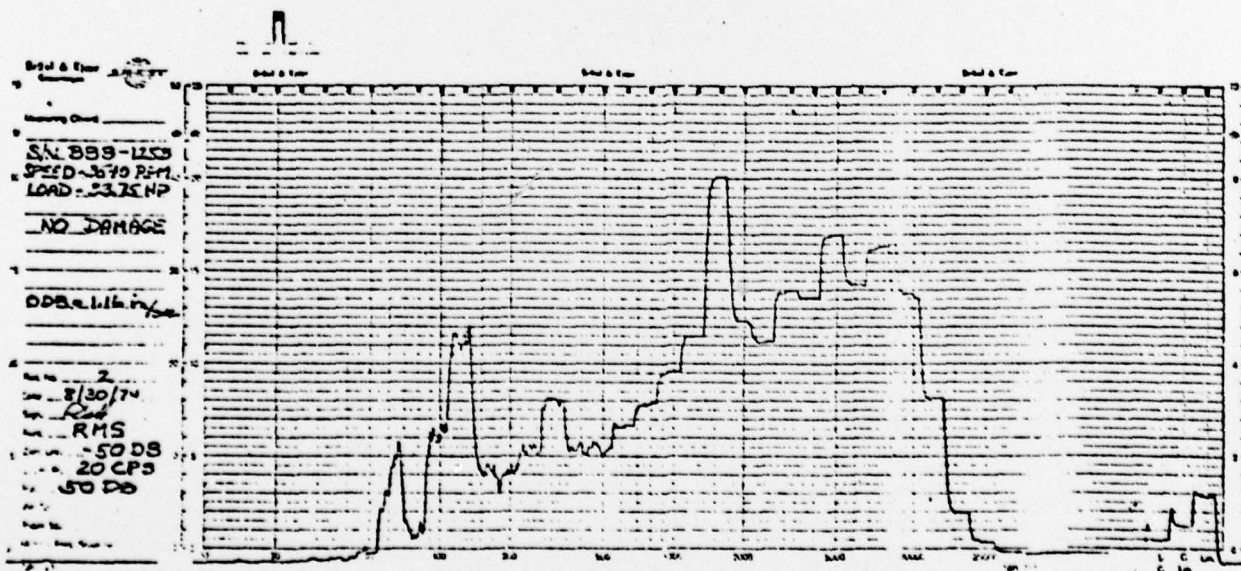
ENCLOSURE 34 AND 35

The B&K traces are shown in Enclosures 34 and 35. As can be seen from the data the gear mesh frequency predominates, and damage gears do not show marked differences (increase in amplitude) as compared to undamaged gears.

It is apparent from the B&K traces that the amplitude of vibration emitted at the gear mesh frequency is very high, due to the meshing impact. The damaged areas come in contact only as the teeth slide across one another. It would appear that the impact of the damage as compared to the impact of the teeth mesh is quite small. The shock pulses emitted by the damage also would occur at a higher frequency. Since the MEPA-10A has proven so successful in the measurement of bearing damage, modification of the electronics should be considered to investigate the shock pulses emitted in the time segment between the meshing of teeth, as a measure of gear damage severity.
